*Report No. BC/MB/03.21.03.Rev.1*

# **Coal Mining Risk Assessment: Land at Gateway Resort, Bynea, Llanelli.**

**Gateway Resort Ltd.**

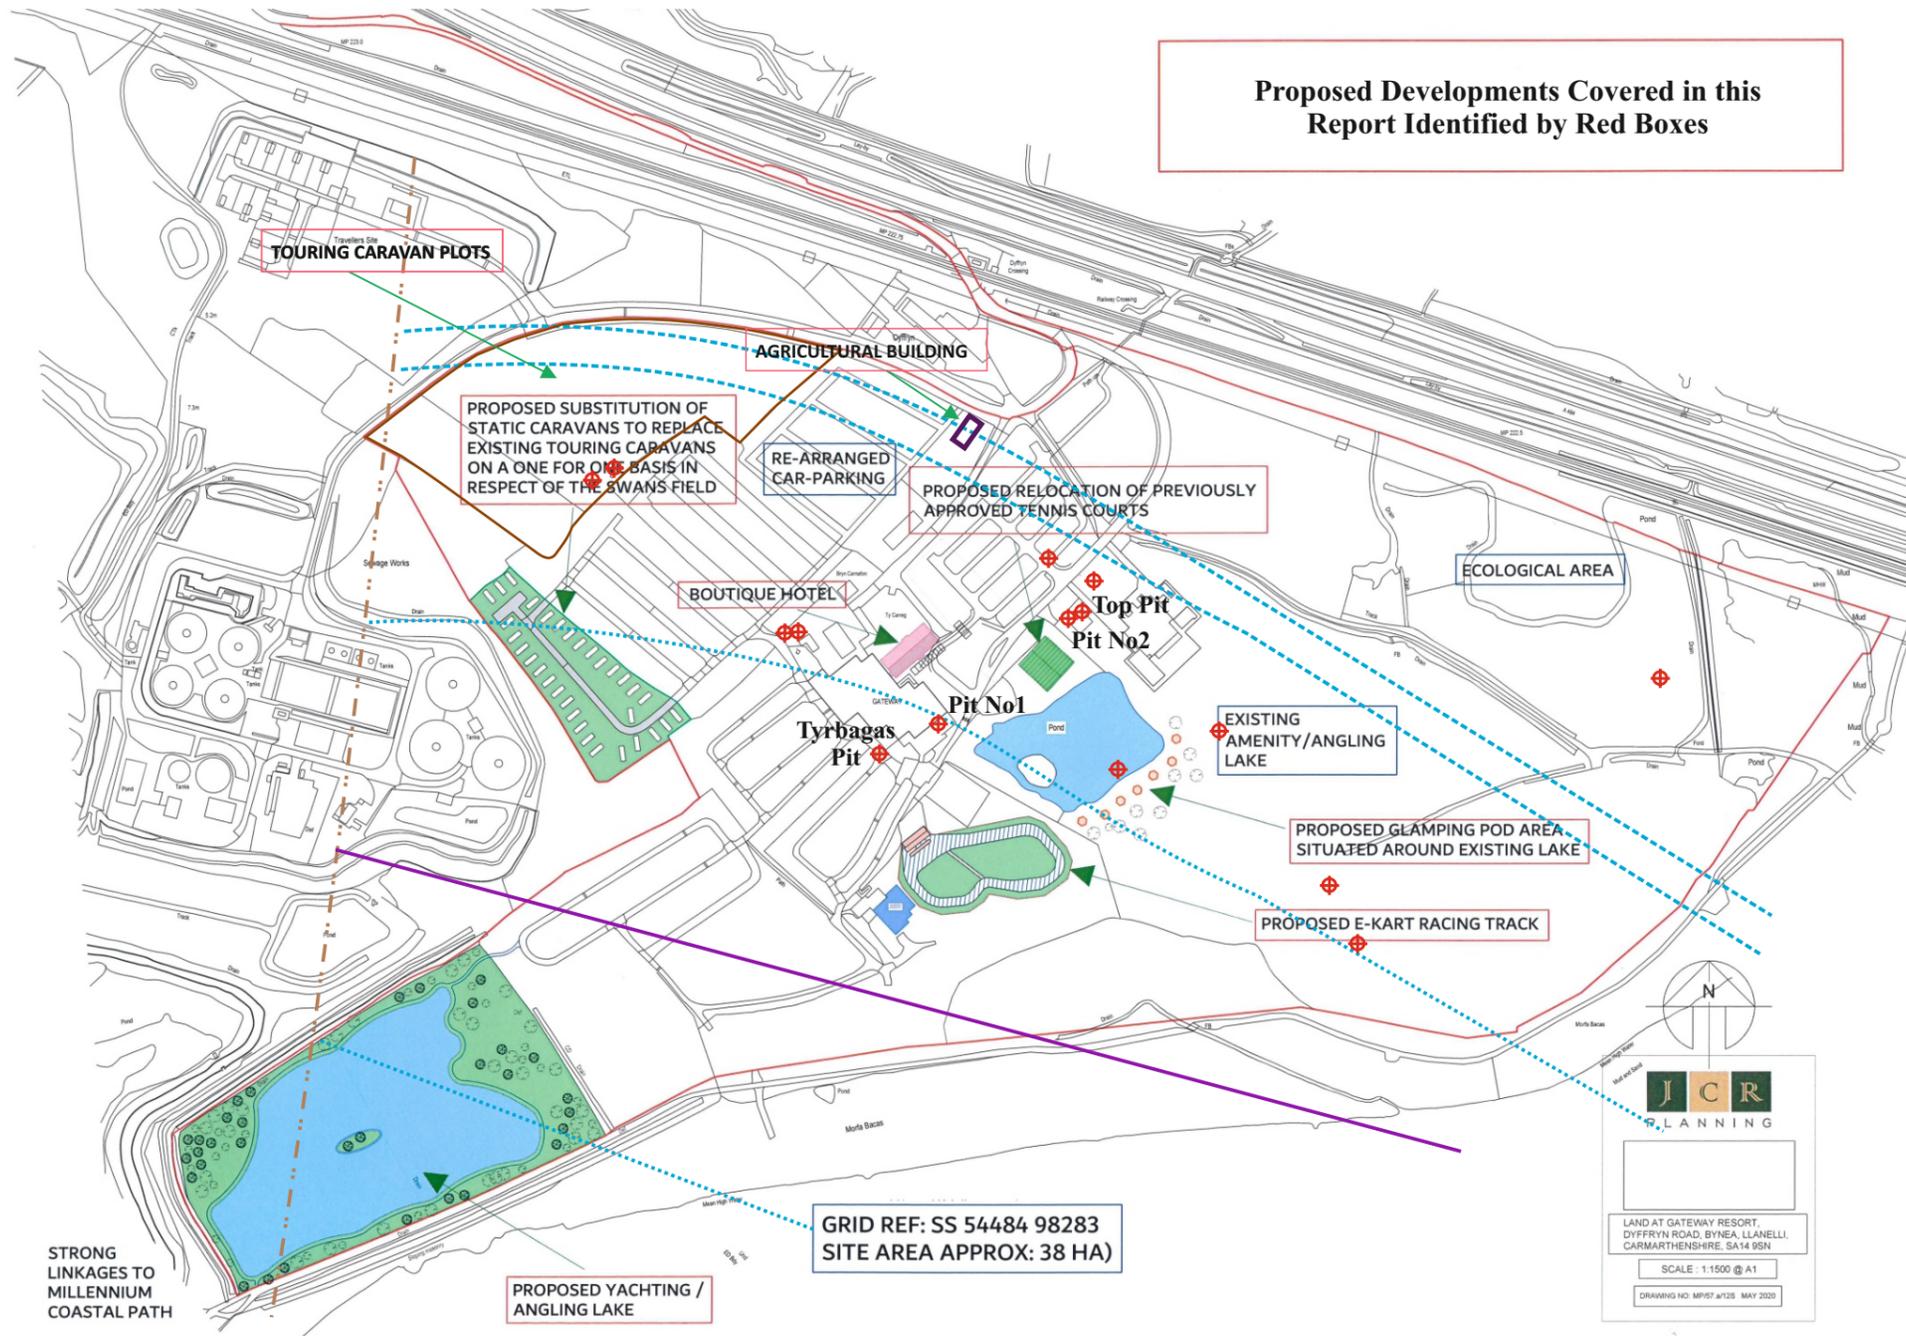
# Layout Plan.

The area is partly underlain with shallow mine workings, posing a risk of surface subsidence. It is recommended that exploratory boreholes are drilled to assess in

There is a recorded shaft close to the location, situated beneath the lake. The precise location of the shaft cannot be determined because of the presence of the lake. It is recommended that trenching is carried out along the bank of the lake near the shaft in order to confirm that the shaft is not present there. The findings of the recommended boreholes will enable an assessment to be made of an exclusion area that should be avoided by the glamping pods.

The area is underlain with shallow mine workings, posing a risk of surface subsidence. It is recommended that exploratory boreholes are drilled to assess in

A fault crosses the area where the lake is proposed. Faults can act as a locus for differential ground movement during earthquake events and where differential subsidence is taking place associated with shallow mine workings. The risk of shallow mine workings being present is extremely low and poses only a very small risk to the proposed lake. Earthquakes are fairly frequent in the United Kingdom, but very few result in any significant ground movement or structural damage. The superficial deposits present would be likely to absorb differential ground movement during most earthquake events likely to affect the lake area. It would be prudent to drill exploratory boreholes to

Proposed Developments Covered in this Report Identified by Red Boxes
